Appendix F

Photograph Log

Outfall Site Visits

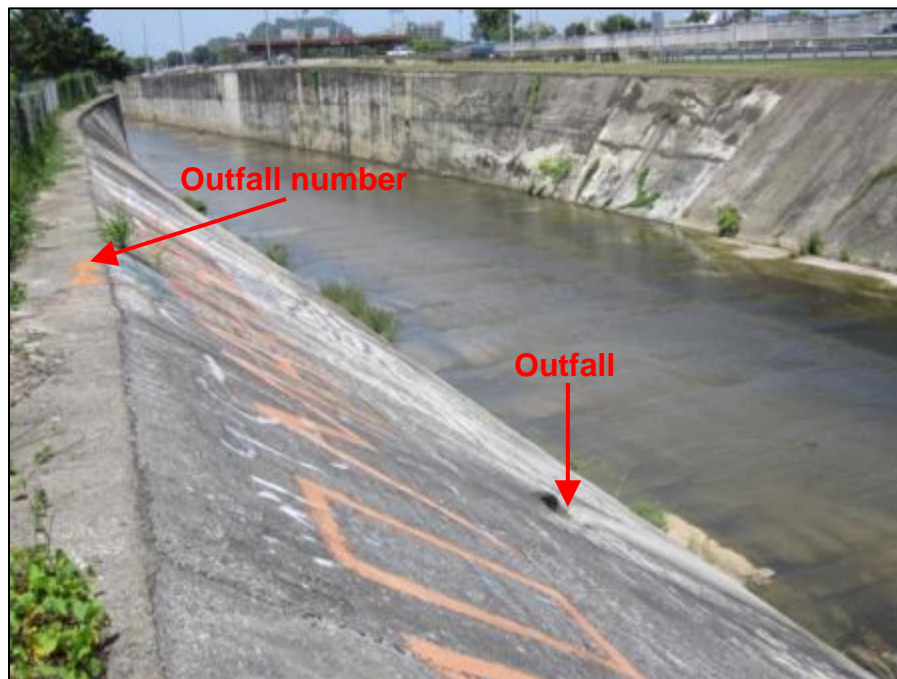
Photograph 1. View of outfalls along east side of the Rio Hondo.

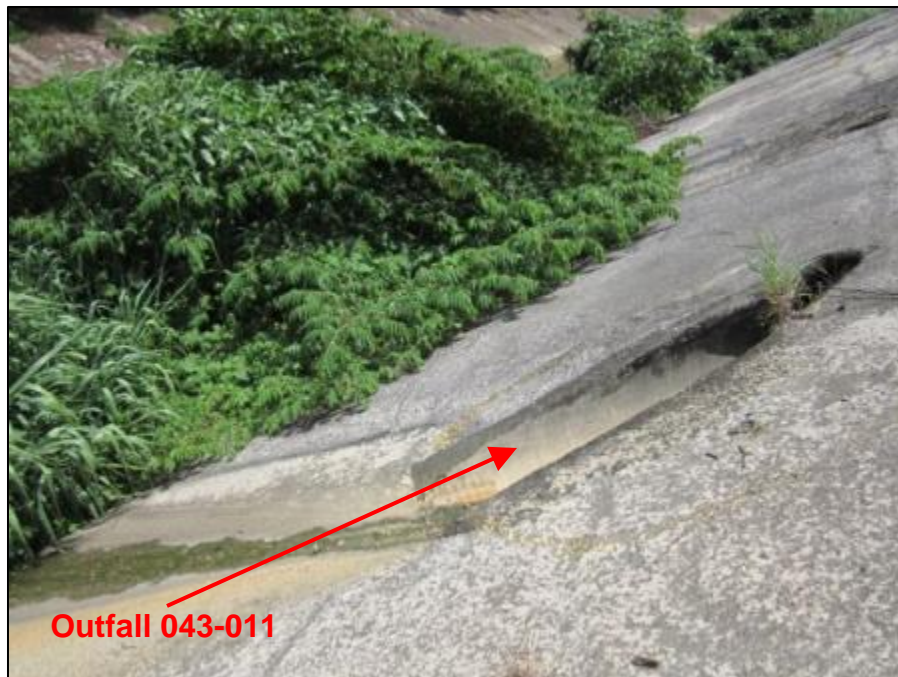
Photograph 7. View of spray painted label for outfall 043-011.

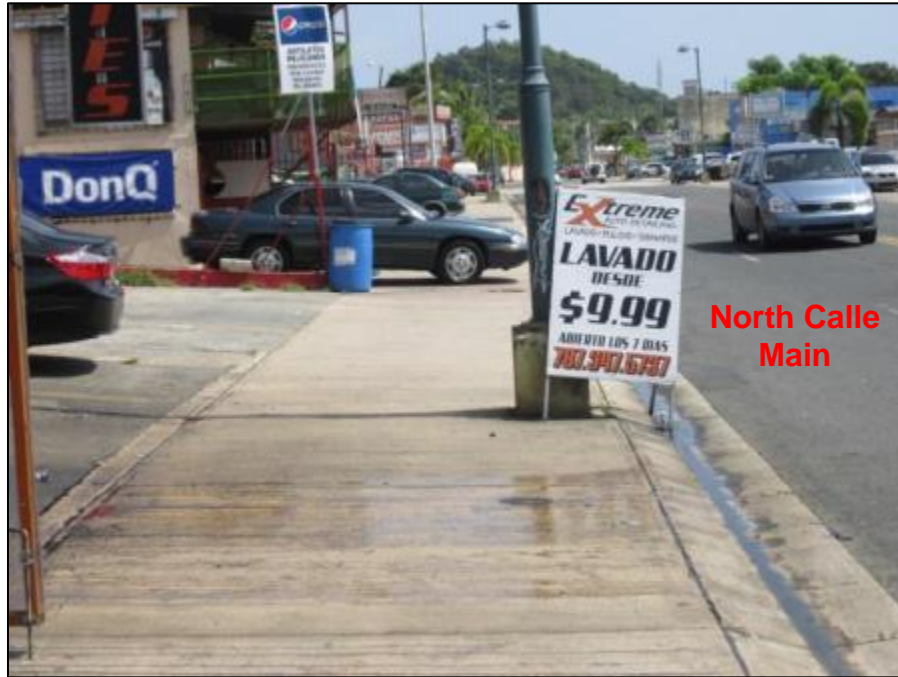
Photograph 11. View of wash water from commercial car washing facility entering drainage along North Calle Main.

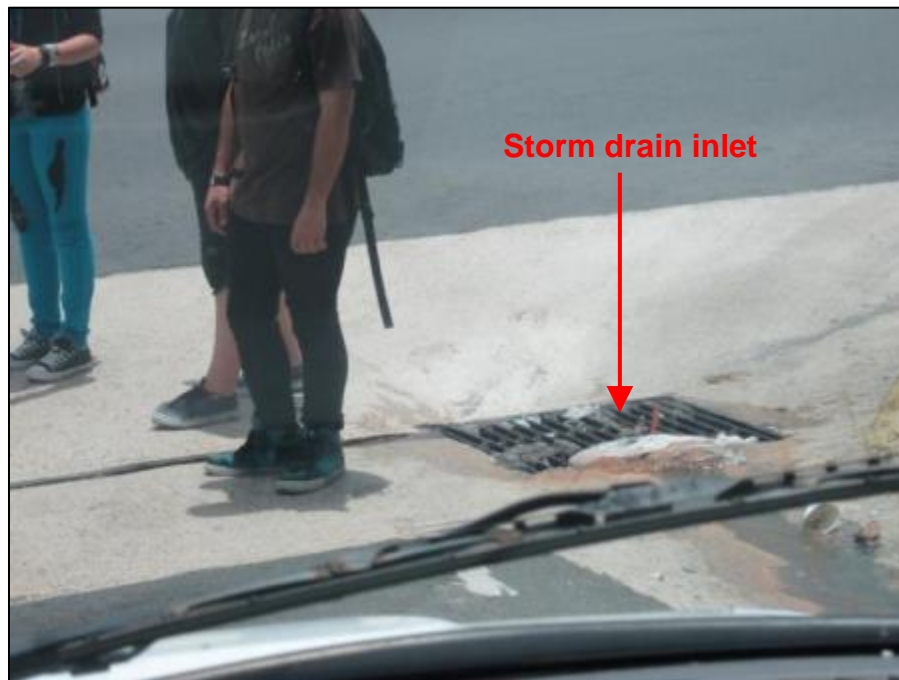
Photograph 21. View of red-colored liquid flowing from pipe in curb to nearby storm drain inlet.

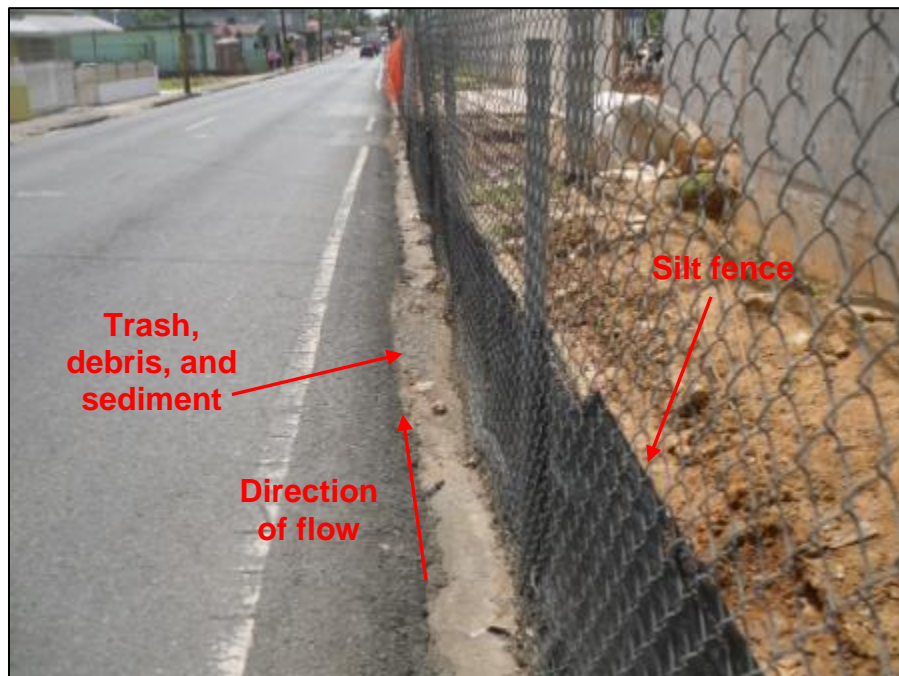
Photograph 25. View of the perimeter of the construction site along Calle Los Millones in the vicinity of the construction entrance depicted in Photograph 23. Note that silt fence was improperly installed and construction site trash, debris and sediment were present in the gutter along the roadway.

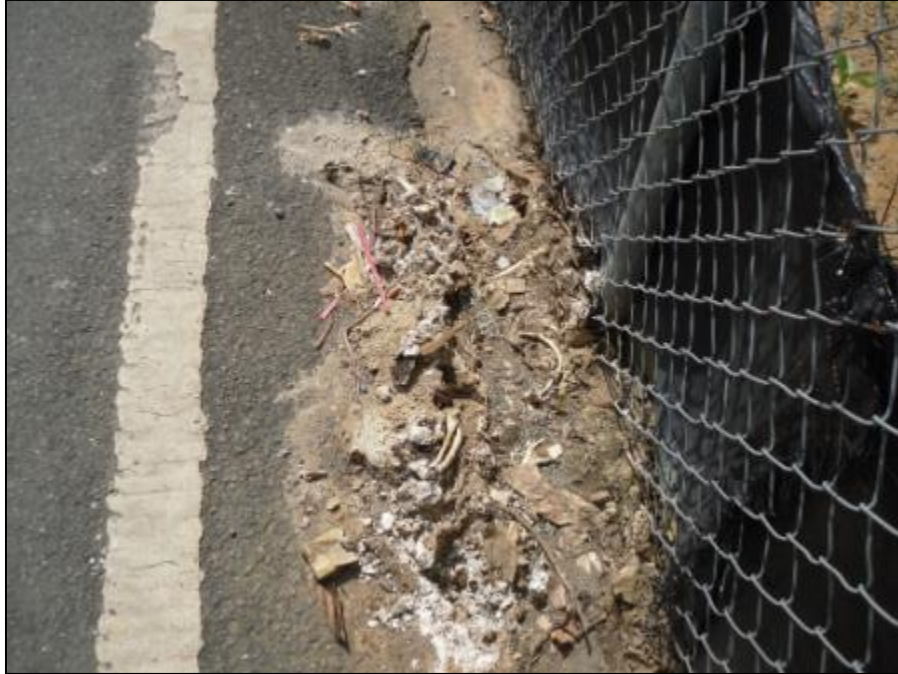
Photograph 26. Another View of the perimeter of the construction site along Calle Los Millones. Note again that silt fence was improperly installed and construction site trash, debris and sediment were observed in the gutter.

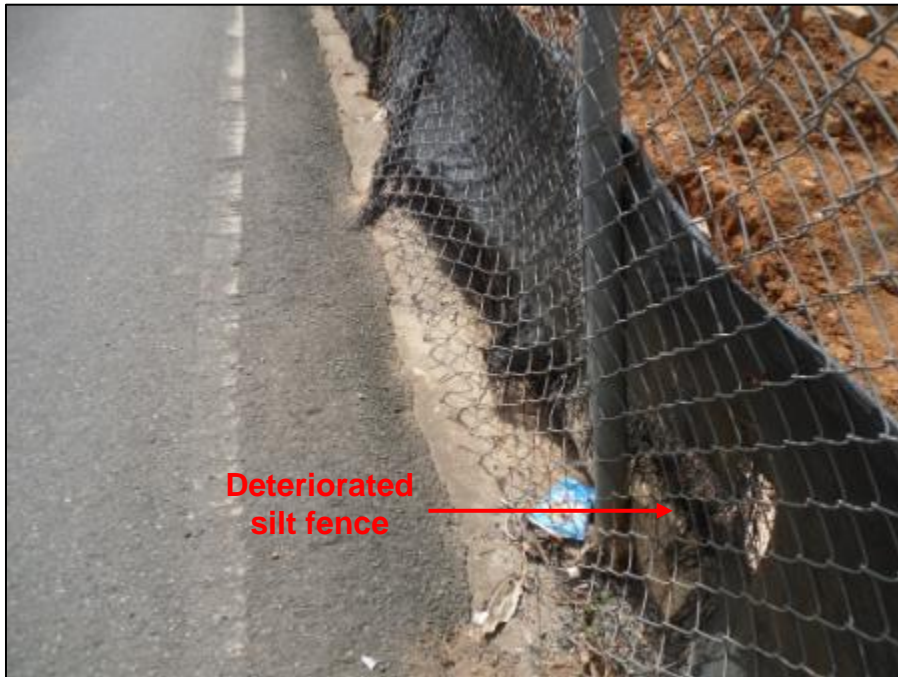
Photograph 27. Close-up view of accumulated construction site trash, debris and sediment in the gutter along the roadway.

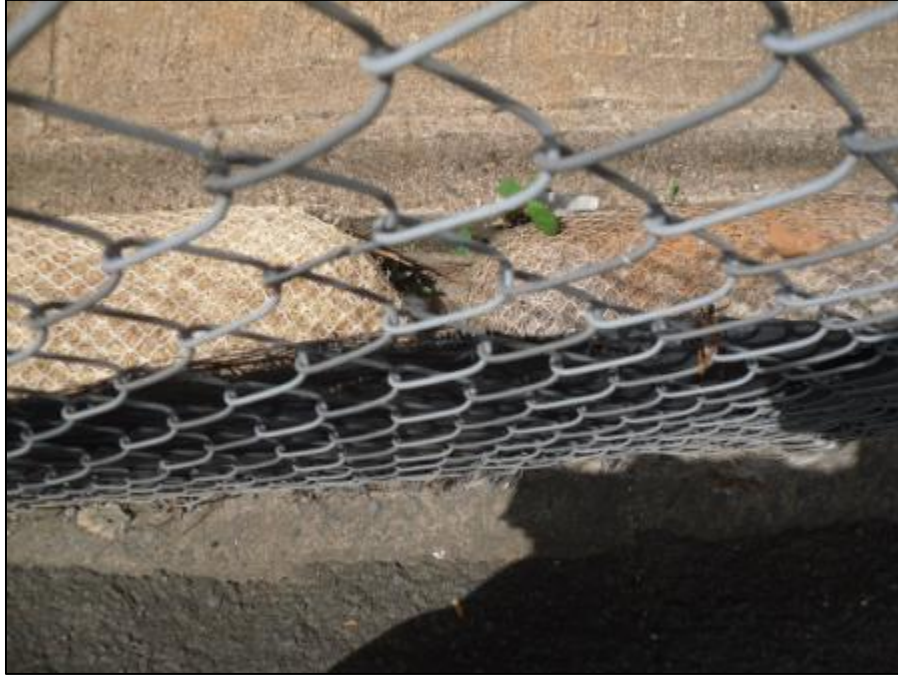
Photograph 28. Example of incorrectly installed (i.e., unentrenched) and deteriorated silt fence along the fence line of Calle Los Millones.

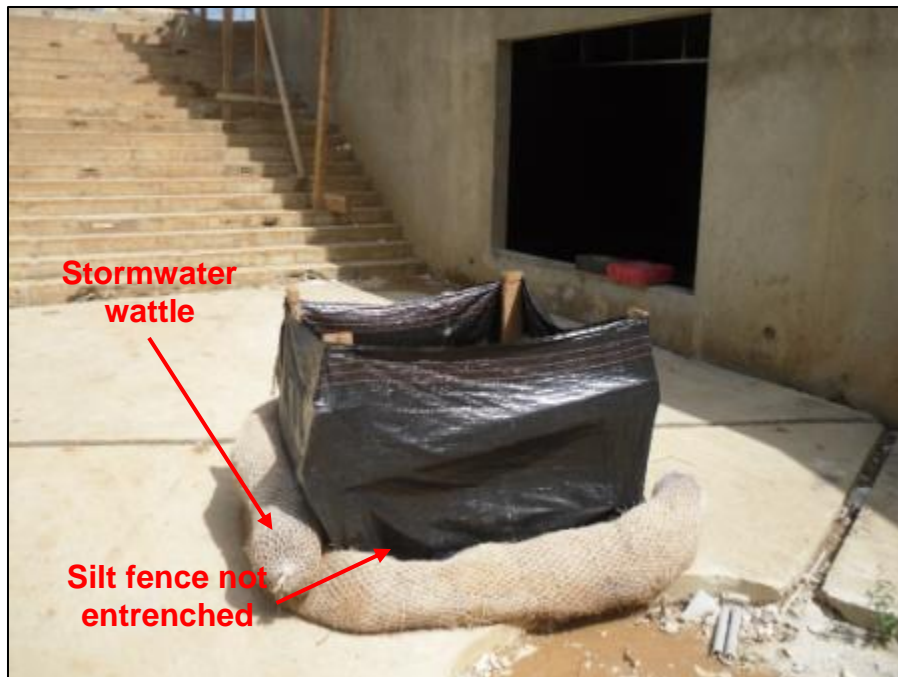
Photograph 29. View of stormwater wattles along the fence line of Calle Los Millones.

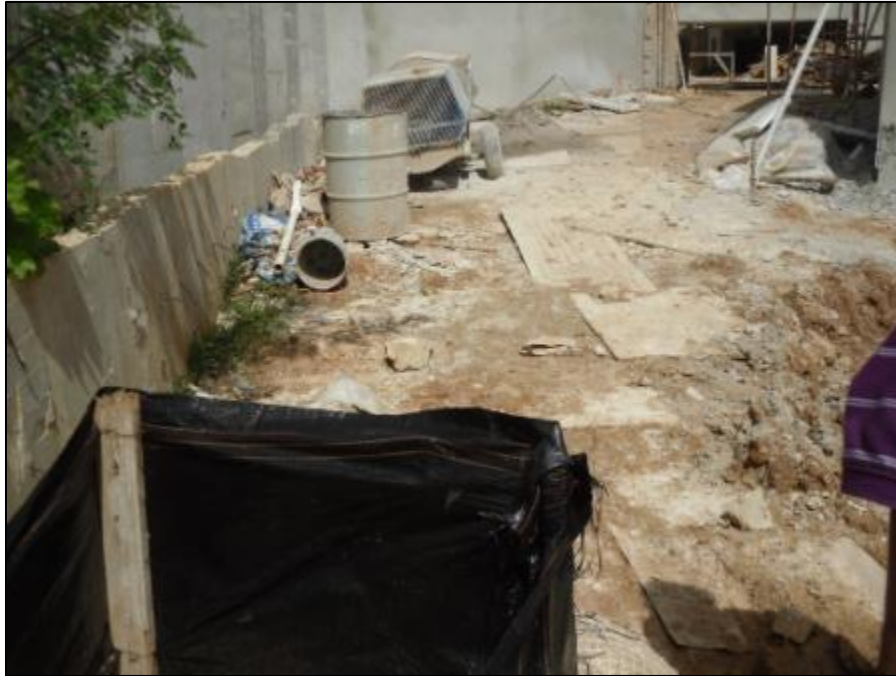
Photograph 32. View of the inside of the silt fence shown in Photograph 31. Note that the inlet structure was also covered by plywood.

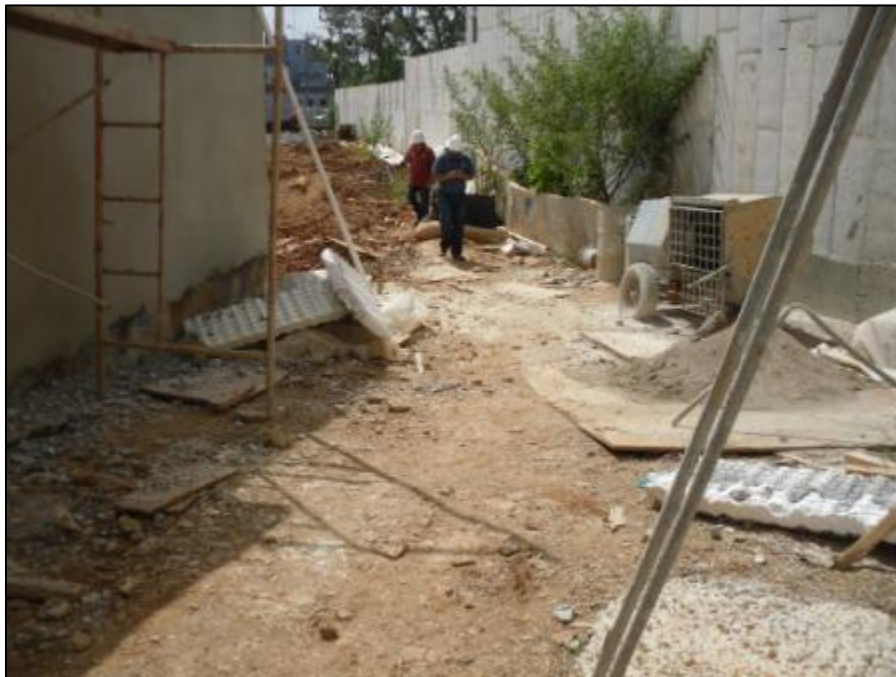
Photograph 33. View of the south side of the construction site located approximately 150 feet from eastern construction entrance from Calle D. Note general trash and debris, concrete mixing equipment, and concrete residue and washout were observed throughout the area.

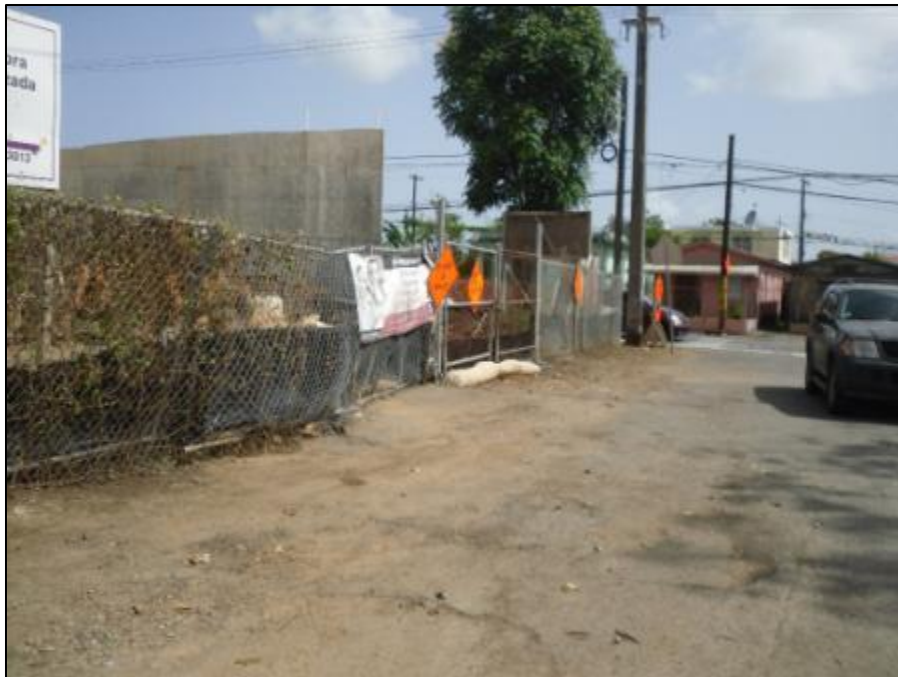
Photograph 37. Close-up view of the silt fence and stormwater wattle show in Photograph 36.

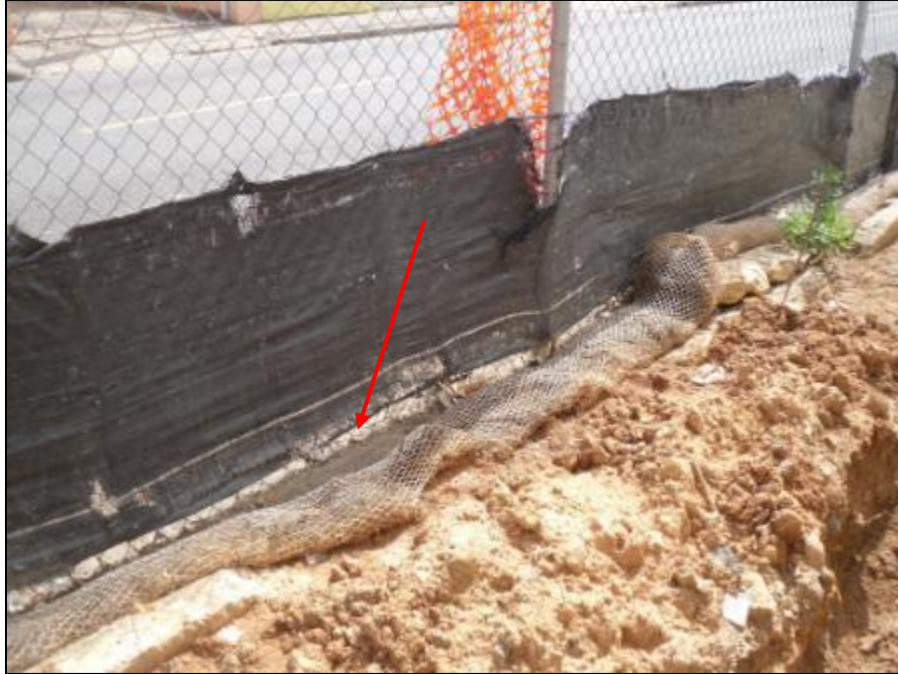
Photograph 40. View from the interior of the construction site of improperly installed silt fence and stormwater wattles along Calle Los Millones.

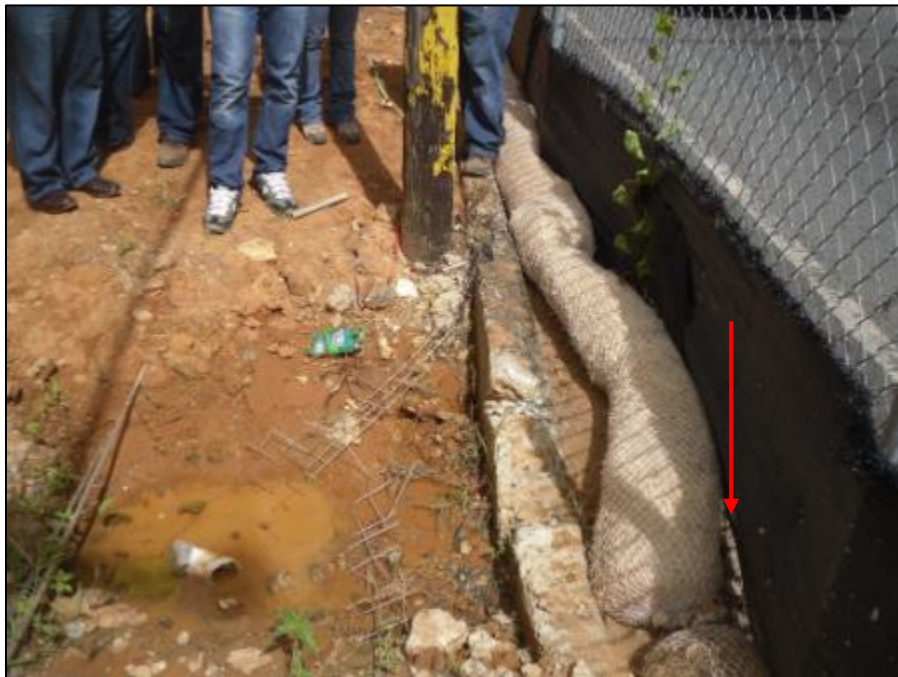
Photograph 41. View from the interior of the construction site of improperly installed silt fence and wattles along Calle Los Millones. Note that the silt fence did not extend the entire distance to the ground.

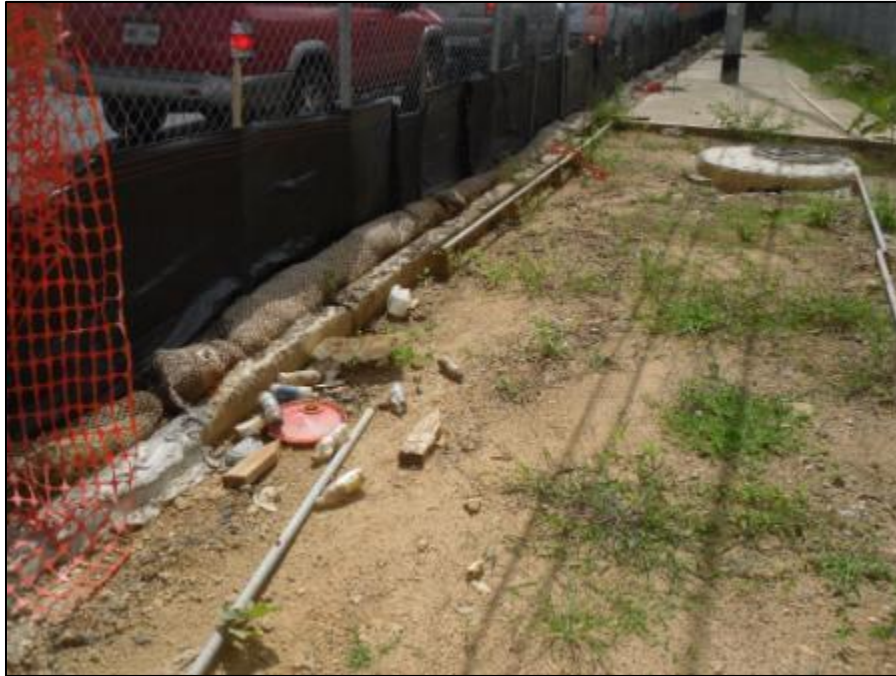
Photograph 42. Another view of improperly installed silt fence and wattles along Calle Los Millones from the interior of the construction site. Note gap at bottom of silt fence.

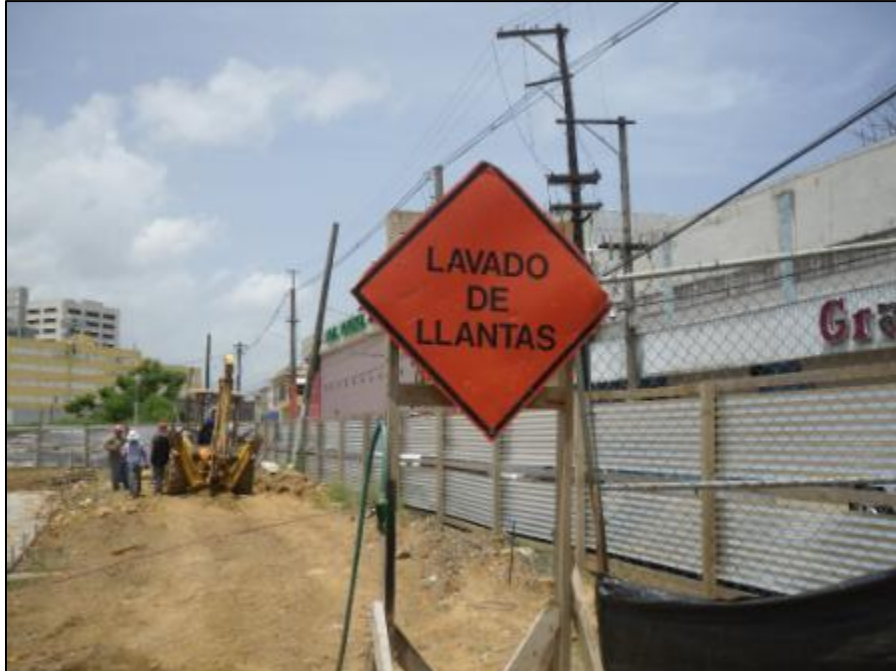
Photograph 44. View of the construction site entrance at Dr. Veve Street. Note that some evidence of vehicle sediment track out and tire wash runoff was observed on Dr. Veve Street.

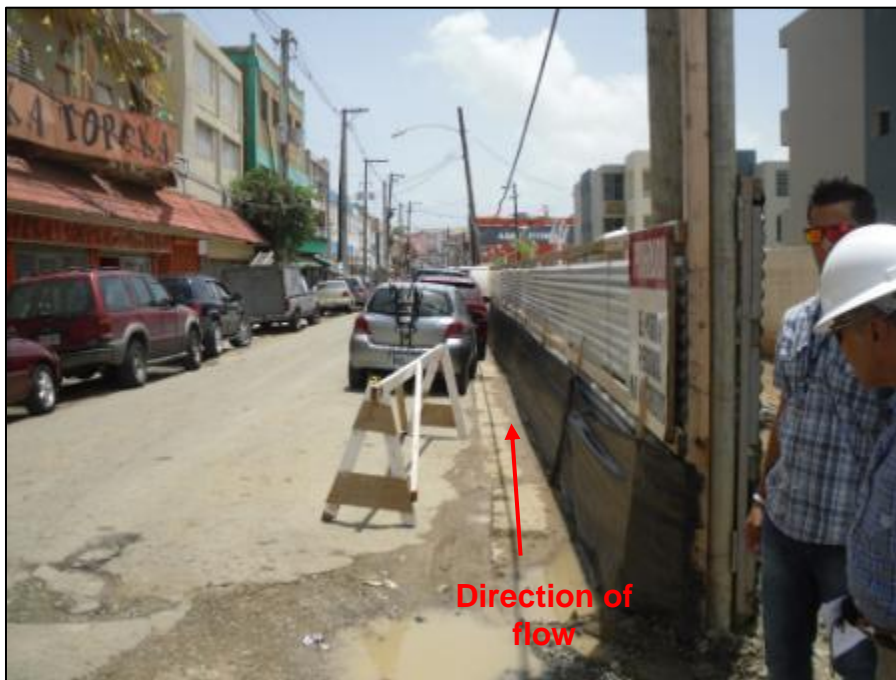
Photograph 46. View of the construction entrance from Dr. Veve Street looking west. Note evidence of tire wash runoff which was tracked onto Dr. Veve Street.

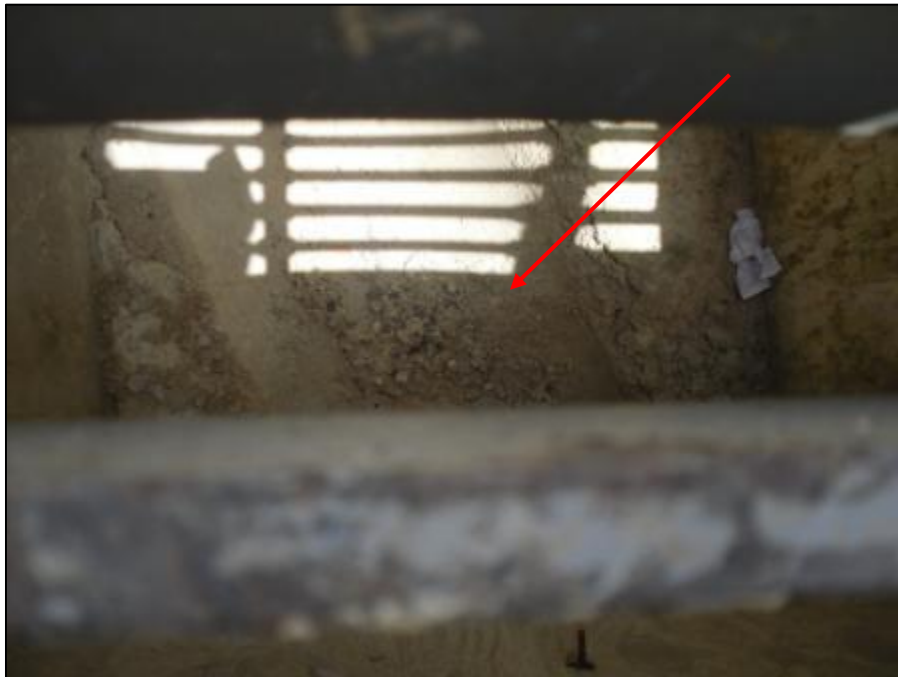
Photograph 50. View of a storm drain inlet along Dr. Veve Street without BMPs for inlet protection.

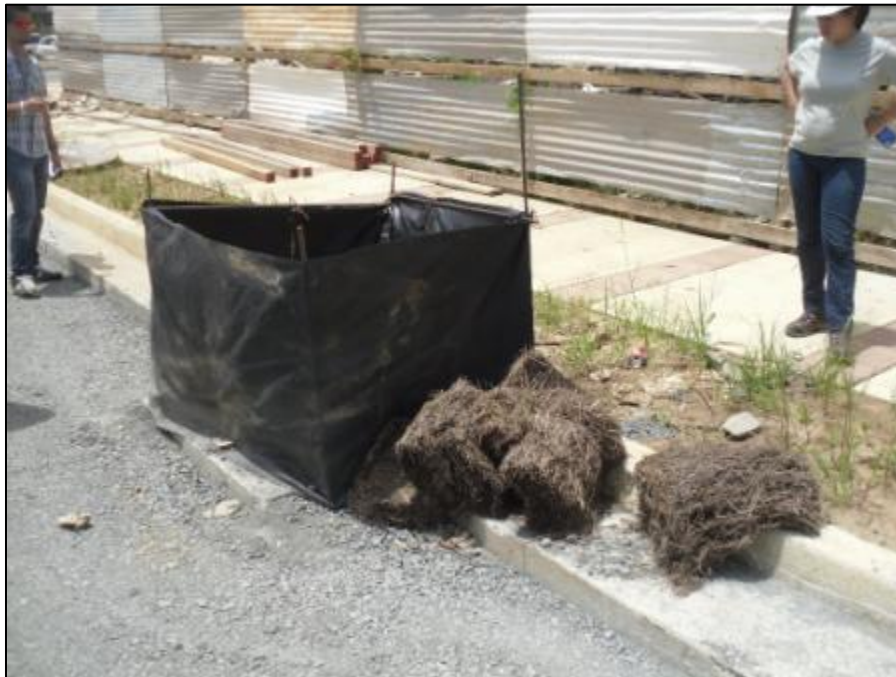
Photograph 58. View of a newly constructed storm drain inlet surrounded by improperly installed silt fence (i.e., not entrenched).

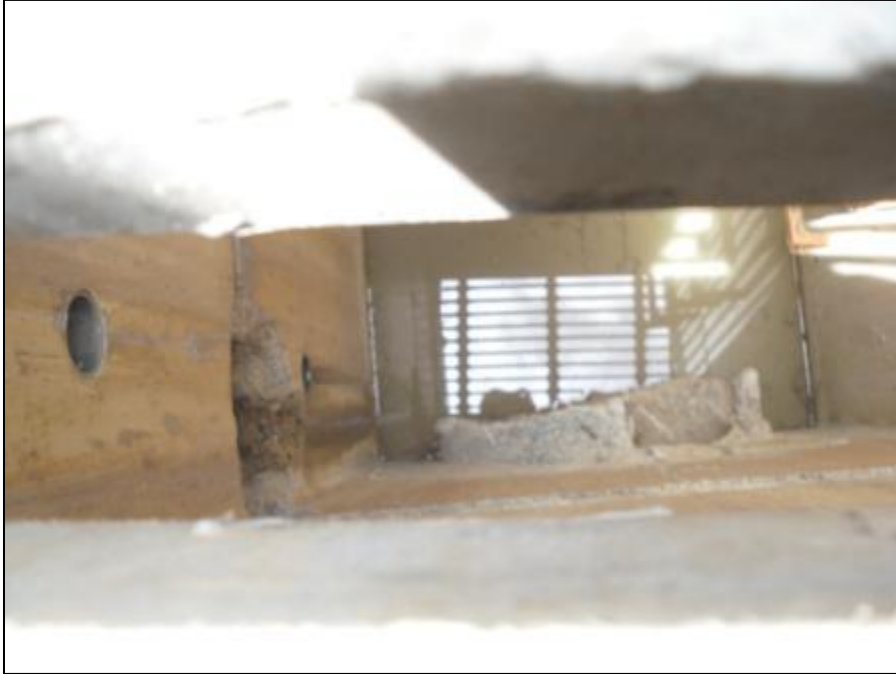
Photograph 59. Another view of the newly constructed storm drain inlet depicted in Photograph 58 surrounded by improperly installed silt fence (i.e., not entrenched), and deteriorated hay bales.

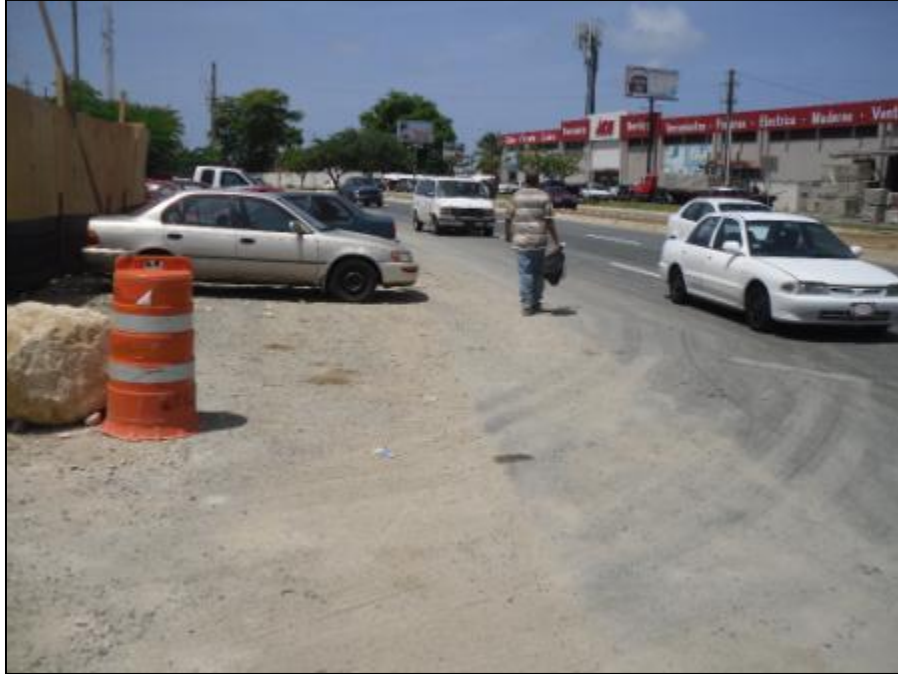
Photograph 67. View immediately outside the construction site entrance on PR-167 facing south. Note that track out from construction equipment and vehicles was observed.

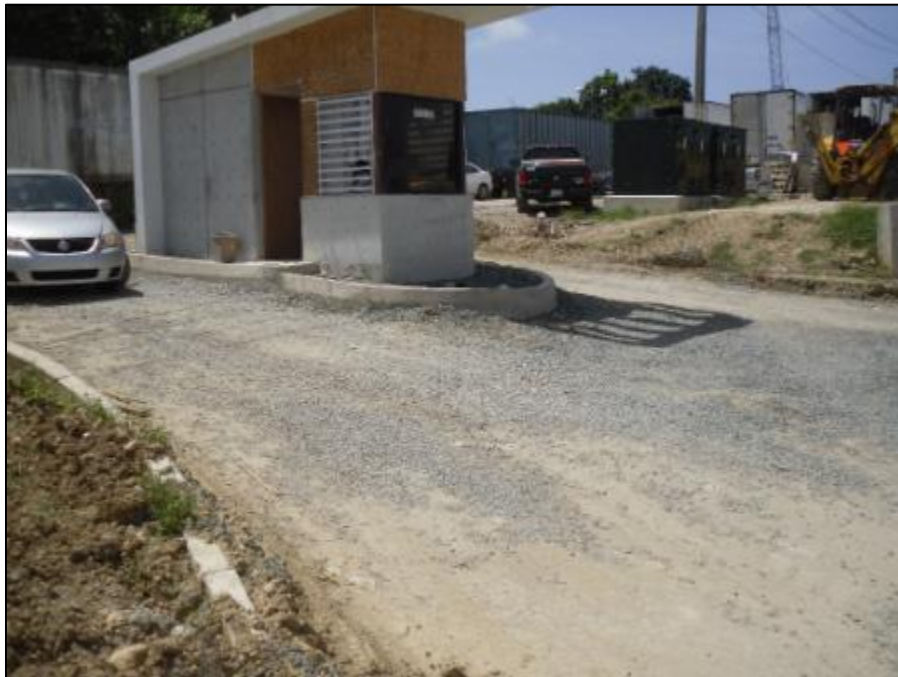
Photograph 68. Alternate view immediately outside the construction site entrance facing north. Note that track out from construction equipment and vehicles was observed.

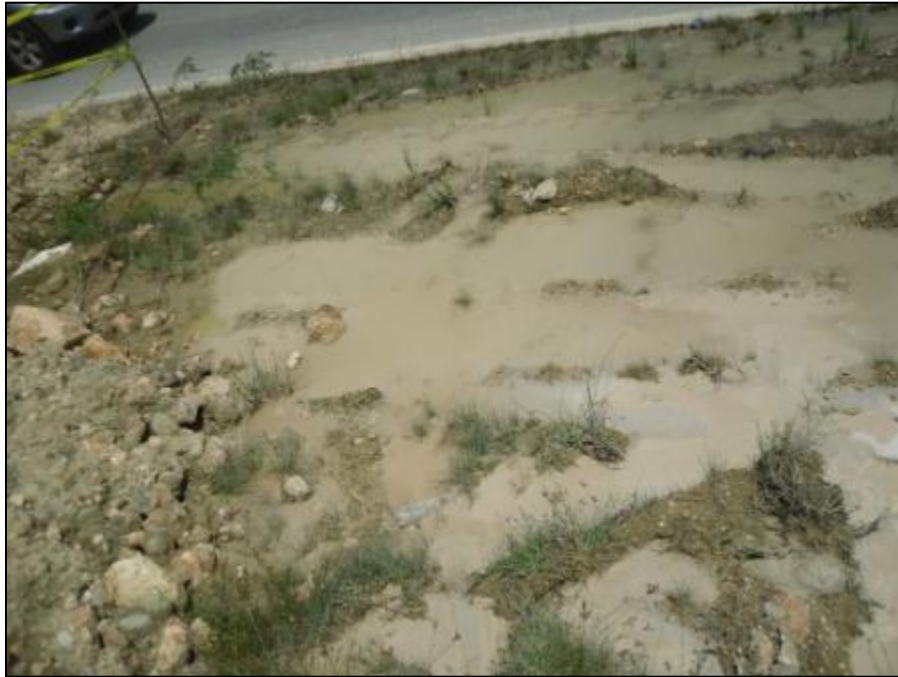
Photograph 72. View of unstabilized washed-out area between the fence line of the construction site and PR-167 to the north of the construction entrance.

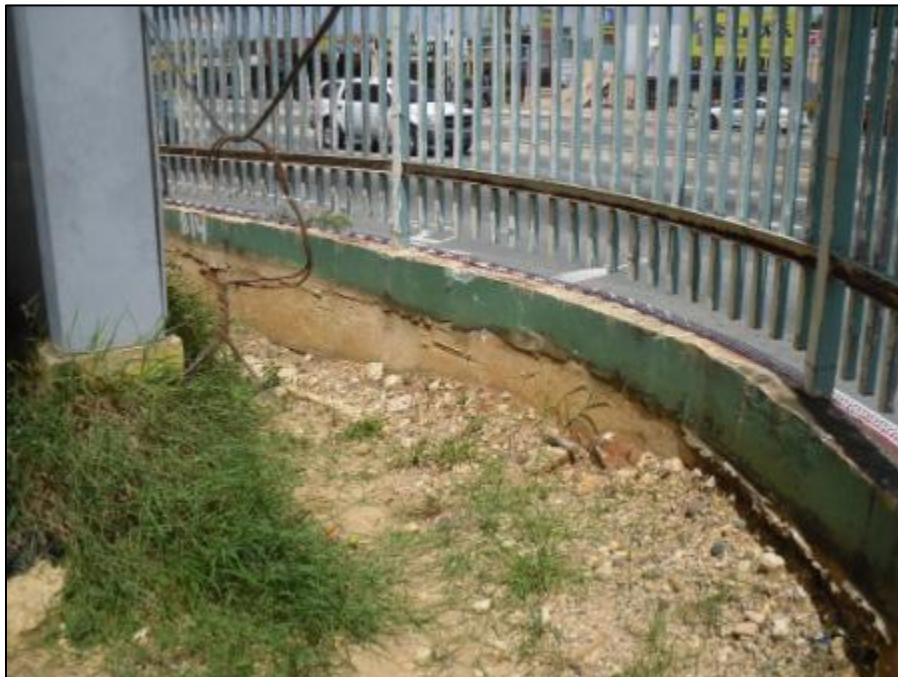
Photograph 80. View of disturbed earth along the fence line of PR-167 immediately north of the southeast corner of the construction site. Note that no perimeter controls are present along the fence line.

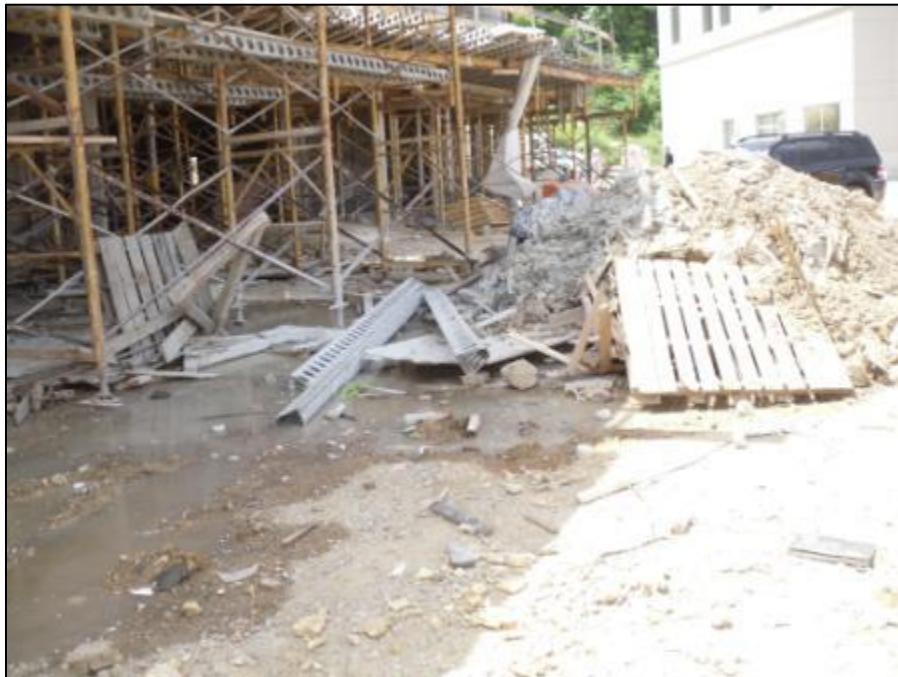
Photograph 86. View of a stockpile of material and scattered debris located immediately to the south of the construction entrance to PR-167 and to the north of the hotel and casino building.

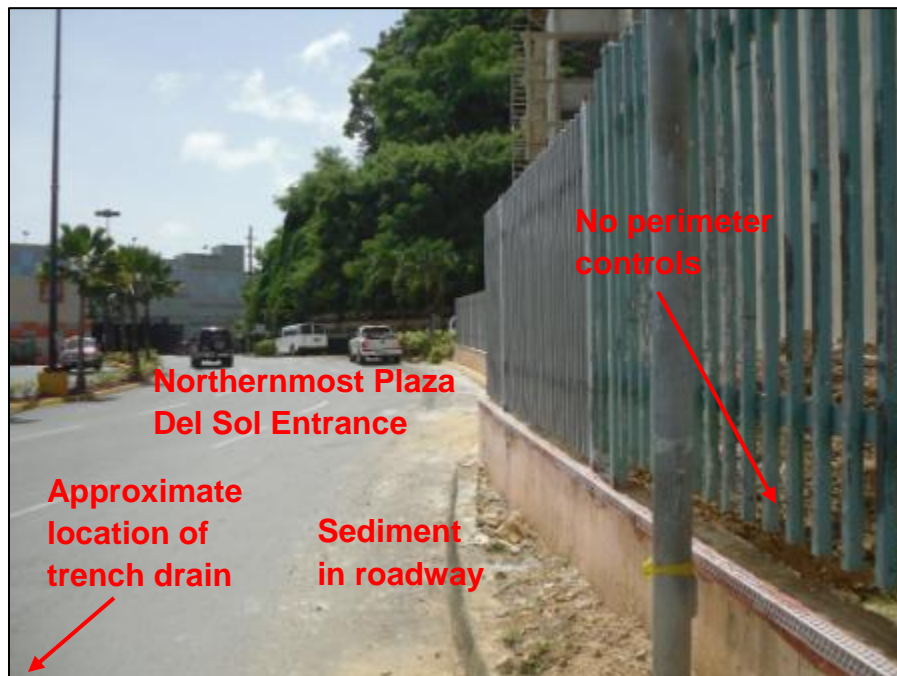
Photograph 88. Exterior view of the northern most entrance to Plaza Del Sol located immediately to the south of the site. Note lack of perimeter controls along the interior fence line and that sediment was observed in the curb and gutter, and in the trench drain across the entrance to Plaza Del Sol (arrow indicates approximate location of trench drain).

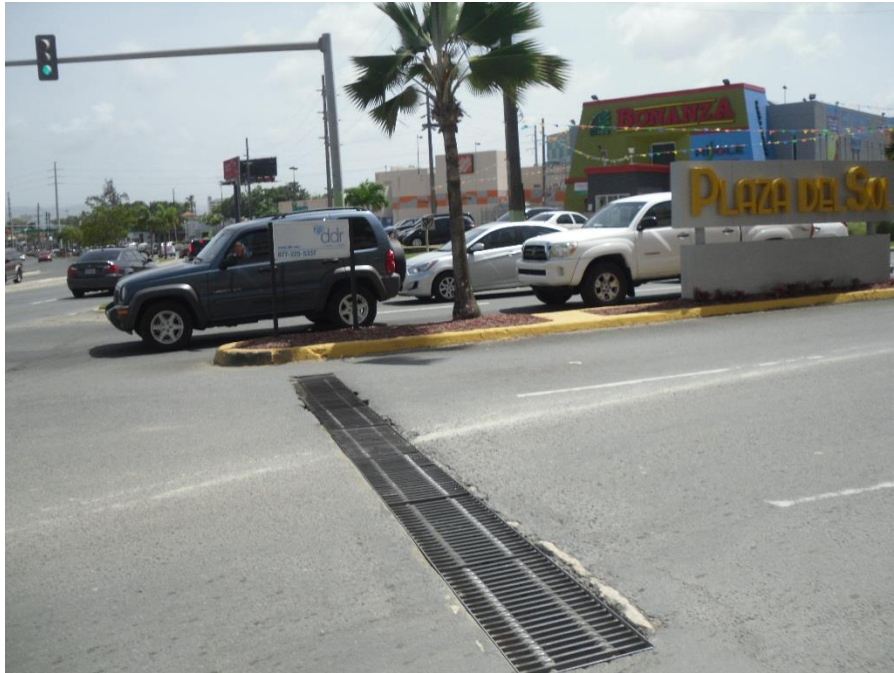
Photograph 89. Alternate exterior view of the northern most entrance to Plaza Del Sol located immediately to the south of the site. Note lack of perimeter controls along the interior fence line, and that sediment was observed in the curb and gutter (arrow indicates approximate location of trench drain).

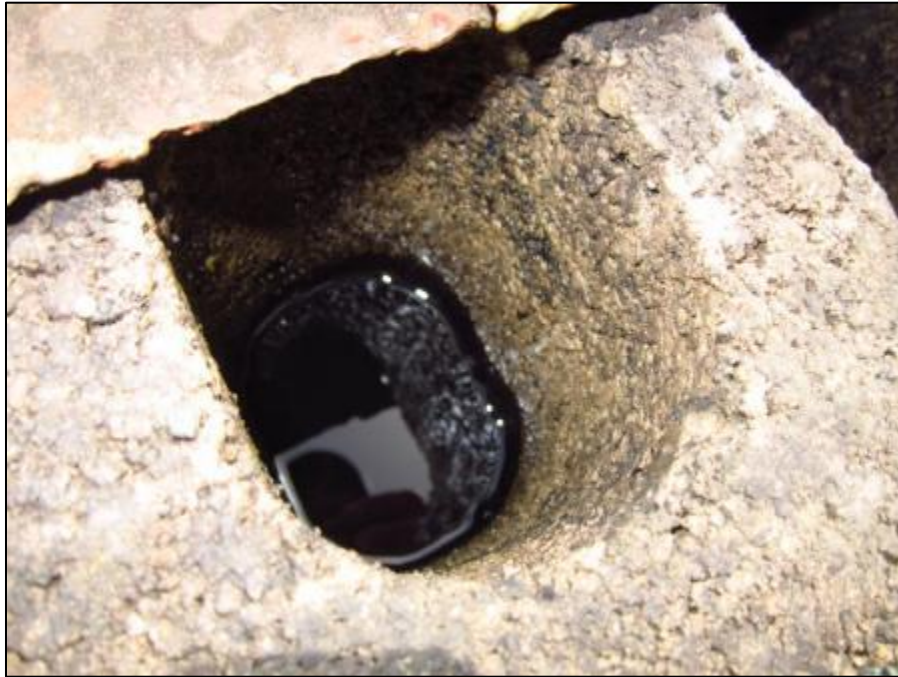
Photograph 110. View of oily liquid accumulated within the holes of the cinder blocks denoted in Photographs 107 and 108.

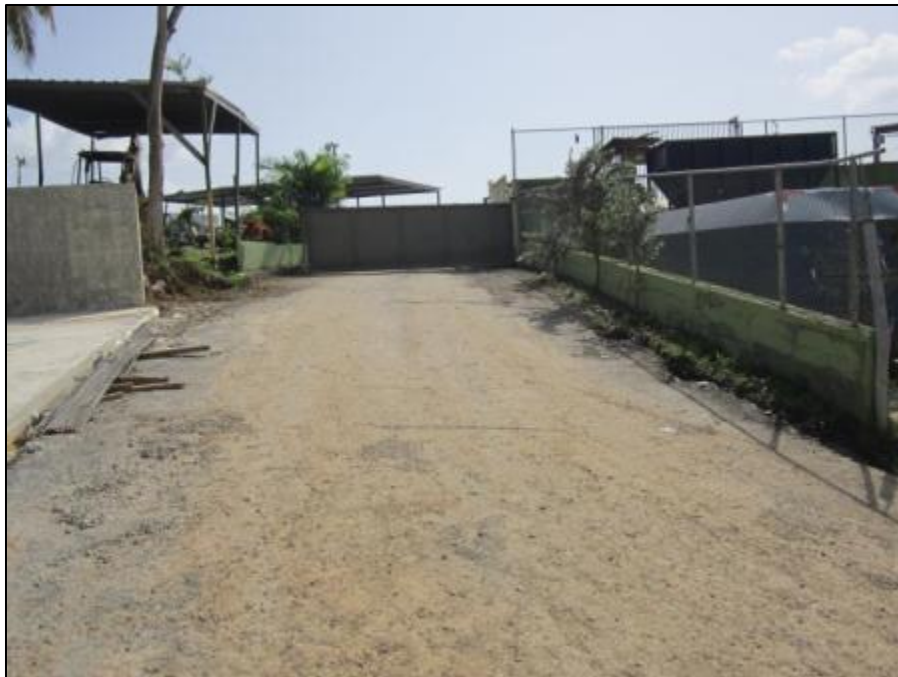
Photograph 115. View to south of unstabilized entrance to vegetative debris stockpile.

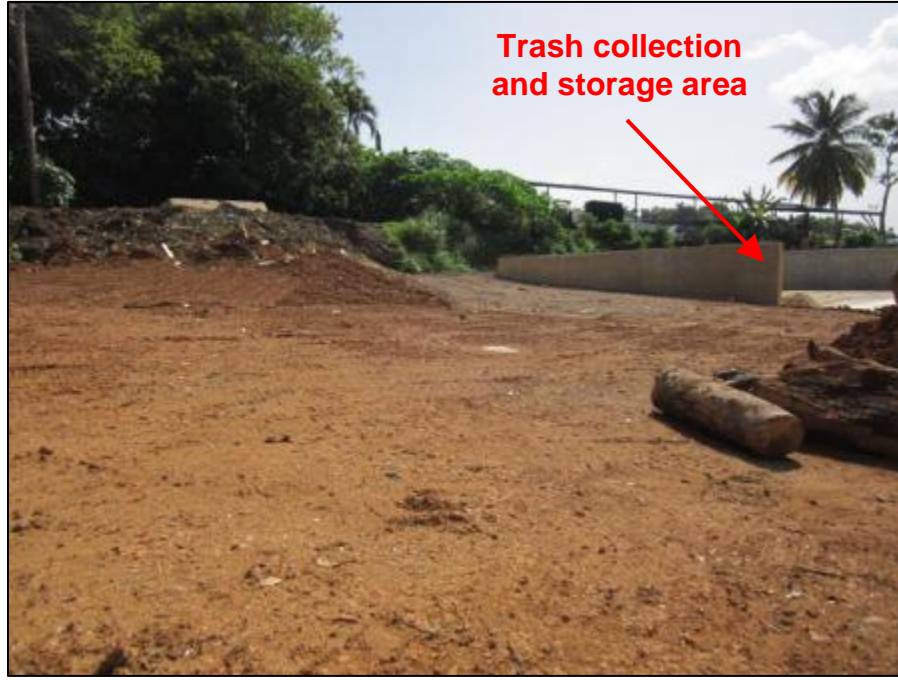
Photograph 118. View facing southeast of active construction area. Note lack of erosion and sediment control BMPs.

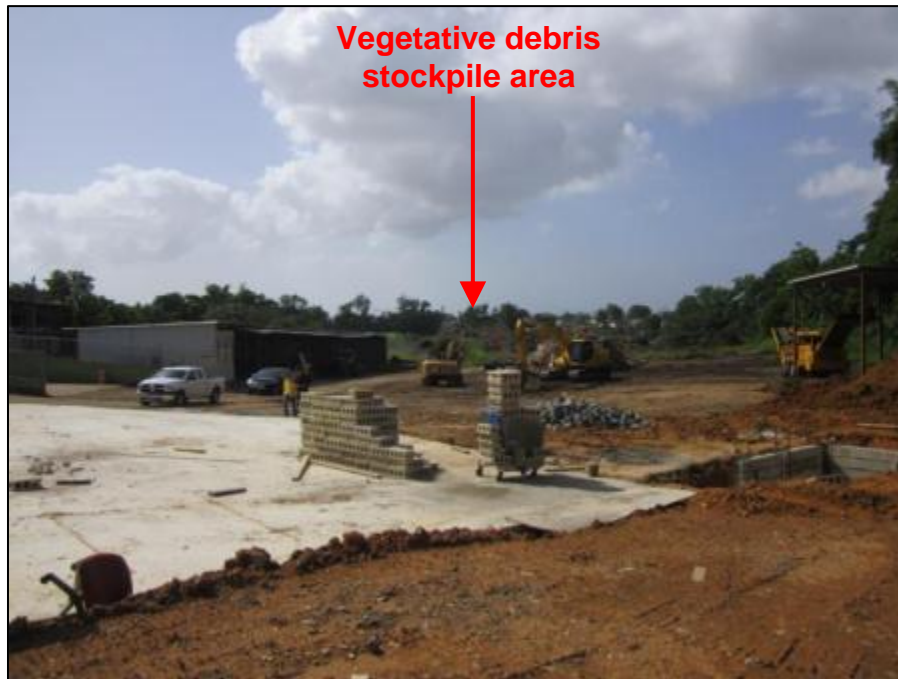
Photograph 119. View facing south of active construction area. Note lack of erosion and sediment control BMPs.

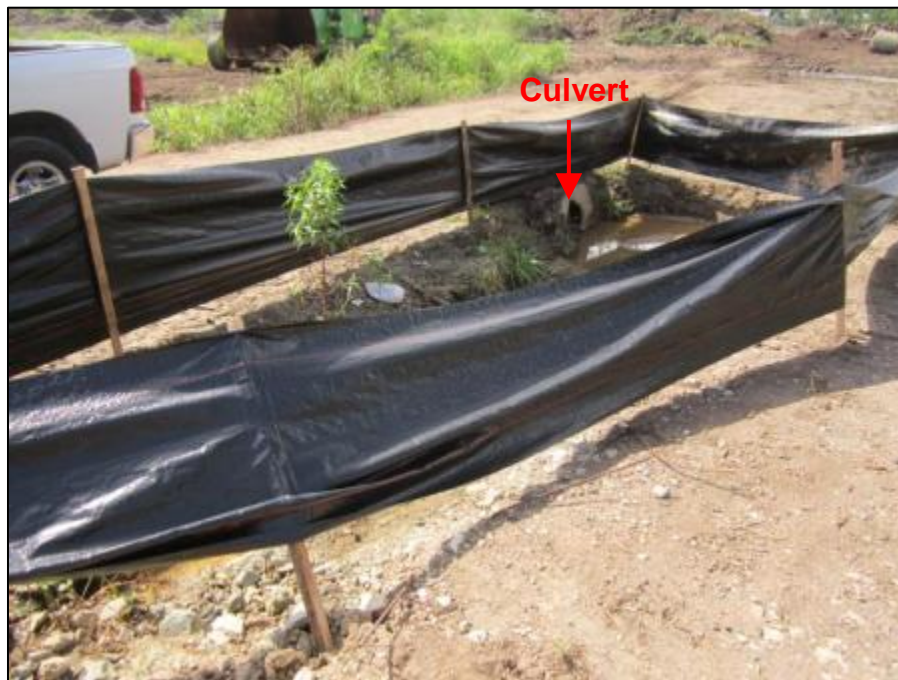
Photograph 121. View of silt fence installed around drainage channel and culvert. Note silt fence is not entrenched into ground and there is a log underneath a portion of the silt fence.

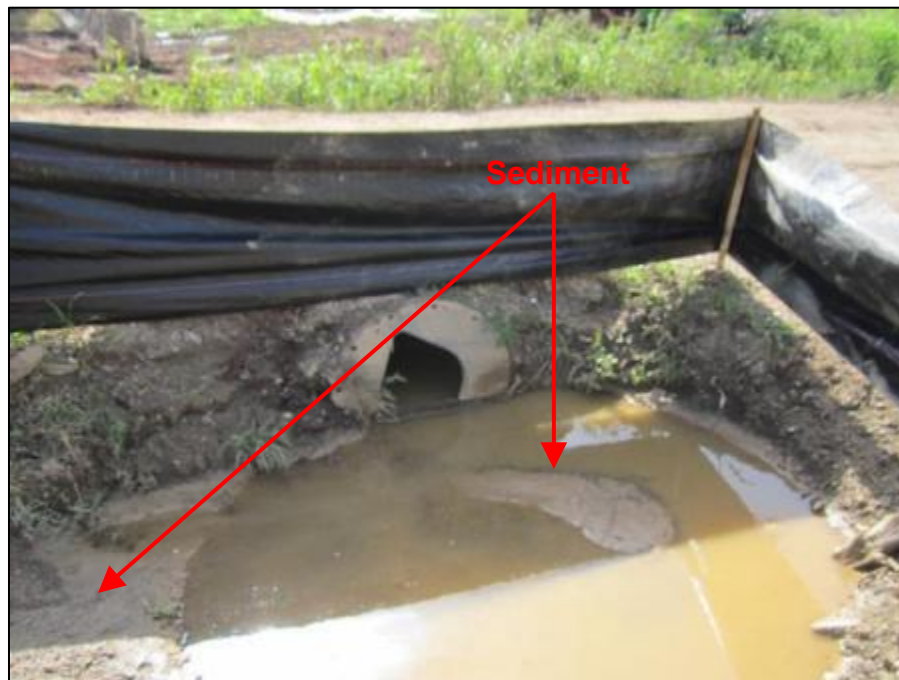
Photograph 123. View of area directly upgradient of silt fence shown in previous photograph. Note flow pathway through upgradient disturbed area.

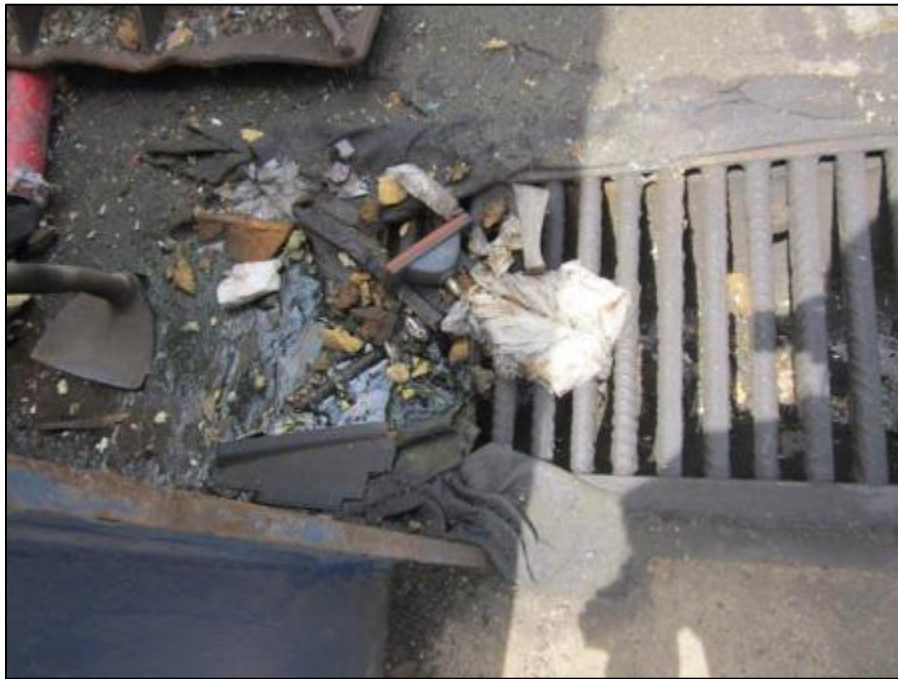
Photograph 134. Closer view of trench drain shown in previous photograph. Note filter fabric material within trench drain.
